NASA TECHNICAL MEMORANDUM

TESTING OF CONTAINERS MADE OF GLASS-FIBER REIN-
FORCED PLASTIC WITH THE AID OF ACOUSTIC EMISSION ANALYSIS

K. Wolitz, W. Brockmann, T. Fischer

Testing of containers made of glass-fiber reinforced plastic with the aid of acoustic emission analysis

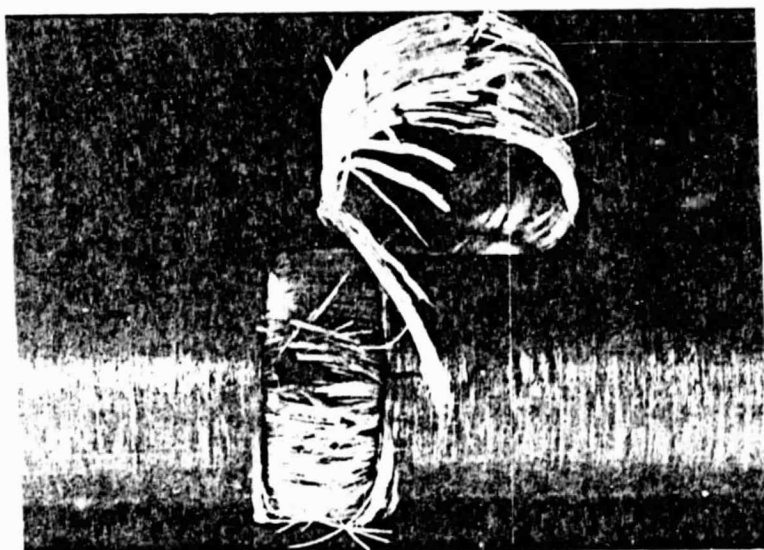
Figure 2:

Unnotched G F K tube after
pressurization 1: 1.7

For a continuously increasing internal pressurization of the test body a hydraulic oil was used whereby it was possible to keep the noises generated by the pressure pump away from the test body by means of pressure hoses located between the pump and the test installation. At a rate of pressurization of about 1 bar/sec the test pieces failed at pressures above 1200 bar which corresponds to a radical tensile stress of 900 N/mm^2 ; the failure occurred abruptly as shown in figure 2. Parallel to the cylinder axis the radially oriented fibers in the composite tore over a length of 2 to 3 cm. Before the failure occurred, i.e., at lower pressure loads, no external damages could be detected on the construction part. To what extent fiber fractures had occurred before the rupture cannot be determined by optical means although one can surely assume that an appreciable part of the elastic energy in pre-damages of the fibers was stored in the test piece before the rupture occurred.

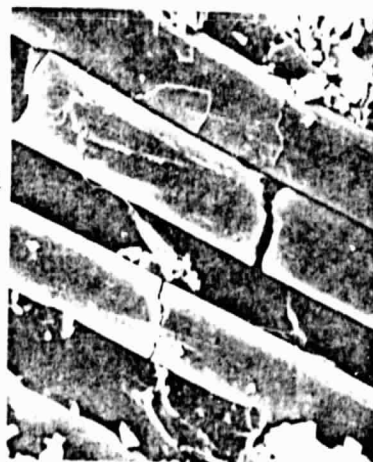
Figure 5:

Intermediate fiber
fractures with ac-
companying SE sig-
nals REM photograph
1500: 1

The representation of the acoustic signals which in earlier tests were evidently caused by intermediate fiber fractures, proceeds, in a time and frequency frame, as shown in figure 5. Corresponding signals from fiber fractures as they appear just before the onset of disturbances are shown in figure 6. If we compare these signal characteristics with each other then it becomes evident that the pulses which are caused by fiber fractures are higher by about 15 dB than those which are attributed to failure of the matrix resin or to delamination. If one, on the other hand, examines the course of the frequency of the pulses, then one finds, especially at higher frequencies, a noticeably greater intensity of the signals than those observed for intermediate-fiber fractures. The observed greater intensity of the signals which presumably is caused by fiber fractures, is in agreement with the results of the amplitude analyses. It can be explained by the liberation of greater energies in the case of fiber fractures. The shape of the frequency spectrum is given by the duration of the emitted pulses. According to the theory of Fourier transforms, a short pulse corresponds to a high-frequency spectrum and a long-duration acoustic event corresponds to a rapid decay of the spectrum toward higher frequencies. If we now assume that the time for a fiber fracture compared to the time for a fracture in the matrix or for a separation of matrix and fiber is very short, then the high-frequency nature of the signals can be clearly attributed to a fiber fracture.
